HAZARD IDENTIFICATION AND VULNERABILITY ANALYSIS (HIVA)

Walla Walla County, Washington

EARTHQUAKE

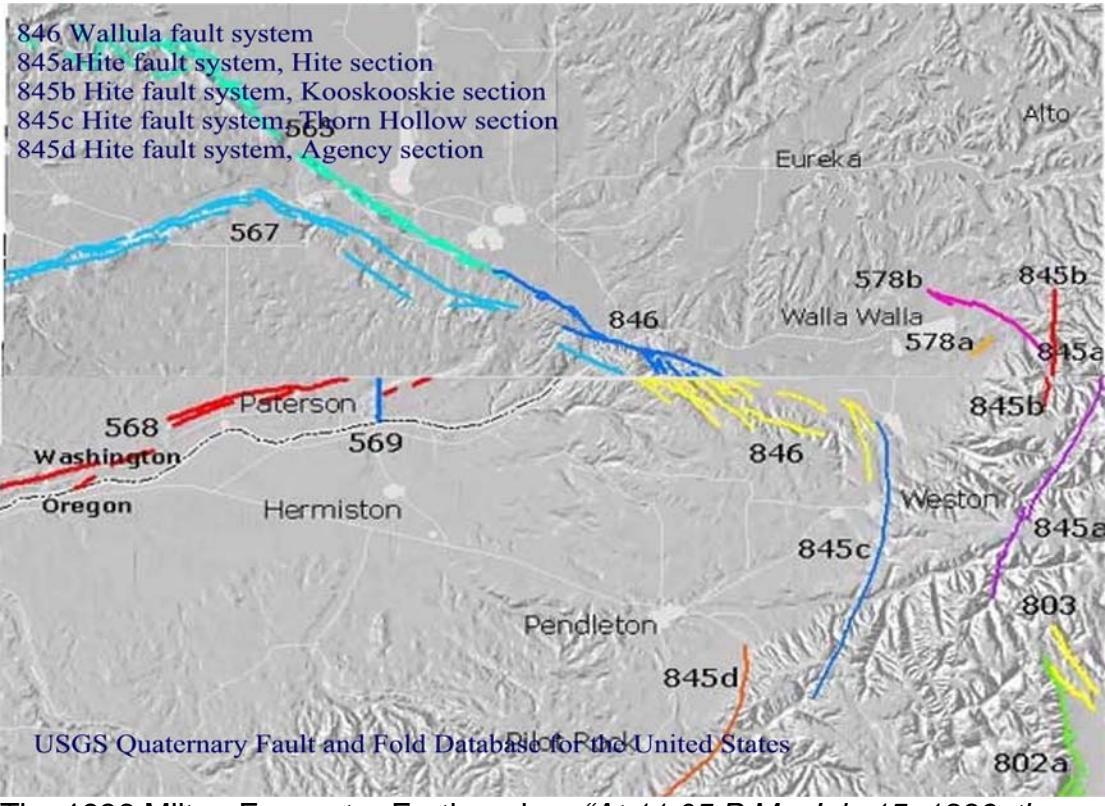
Two fault systems are located in Walla Walla County. The <u>Hite Fault System</u> is located along the foothills of the Blue Mountains stretching generally north and south. The <u>Wallula Fault System</u> stretches from the Wallula Gap on the Columbia River toward Touchet. A map extract showing the location of these faults is shown here.

A geological system called the <u>Olympic-Wallowa Lineament</u> (OWL) stretches from the Olympic Mountains to the Wallowa Mountains through Walla Walla County. The OWL is a series of geological features that indicate a history of earthquake action.

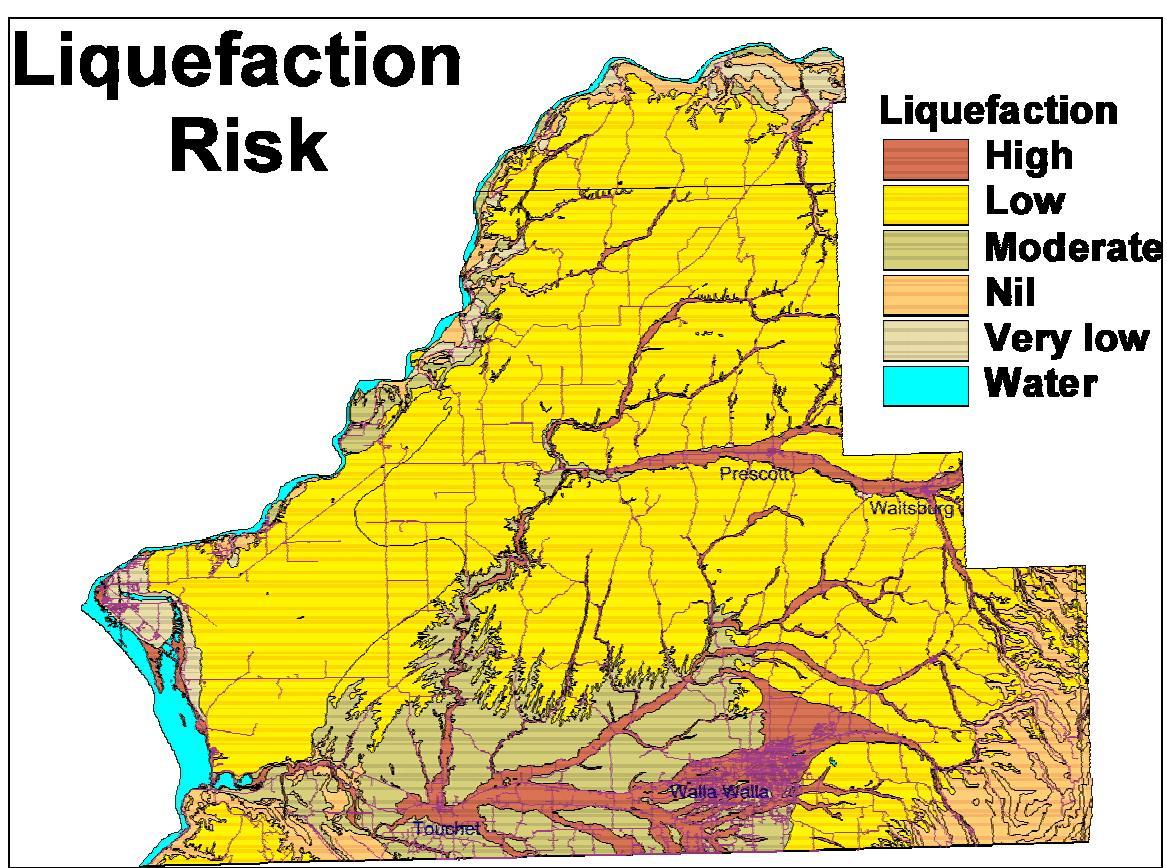
The Liquefaction Risk Map shows the relative level of risk for additional earthquake damage as a result of liquefaction.

To estimate your susceptibility to liquefaction, see Liquefaction Risk map on page 5.
